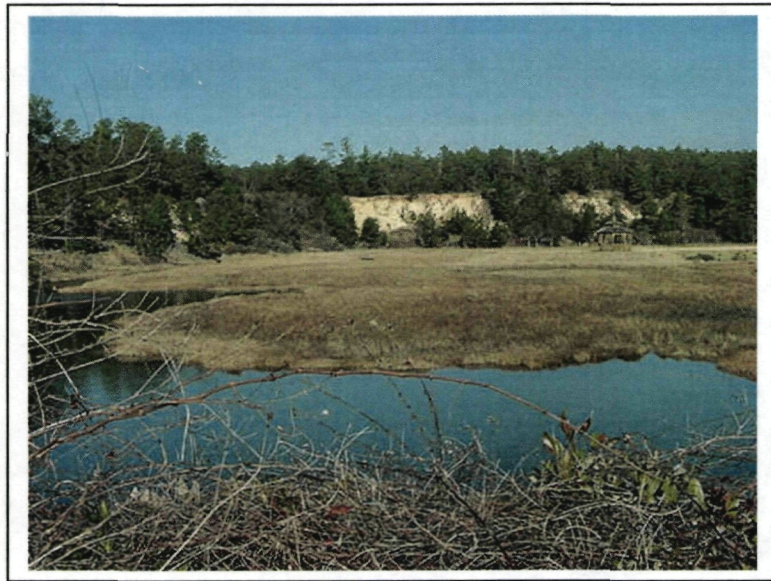
Photo 1. Southern end of pond, facing N, overgrown with *Panicum* spp.

None of the proposed mitigation plants could be seen in any of the proposed locations. The pond is being overrun by a species of *Panicum*.

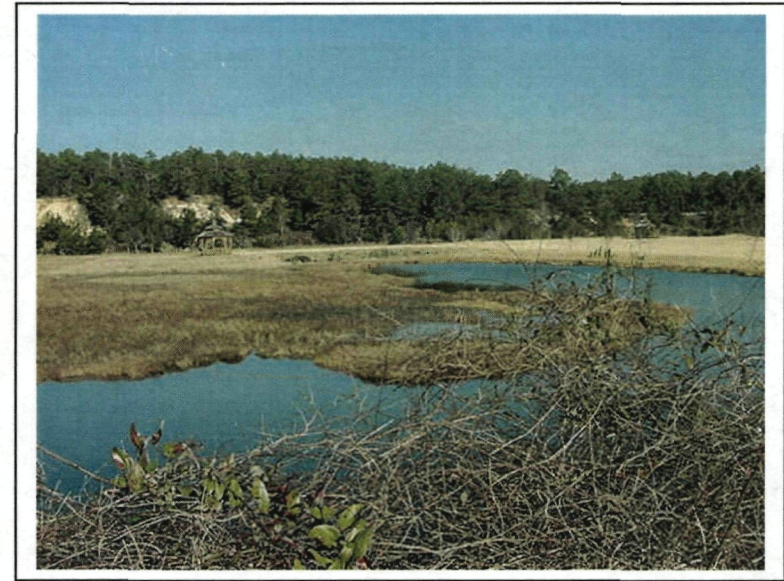
Photo 2. Southern end of pond, facing NE

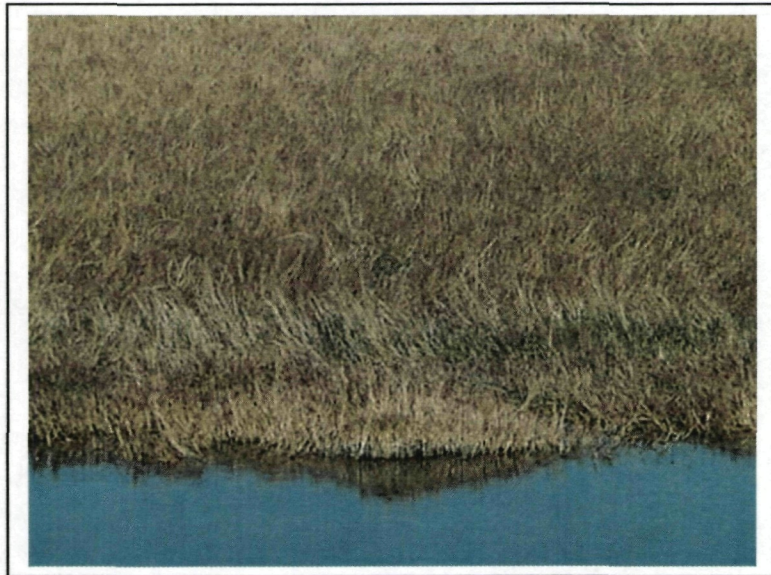
Photo 3. Very dense *Panicum* spp. grass choking out the pond.

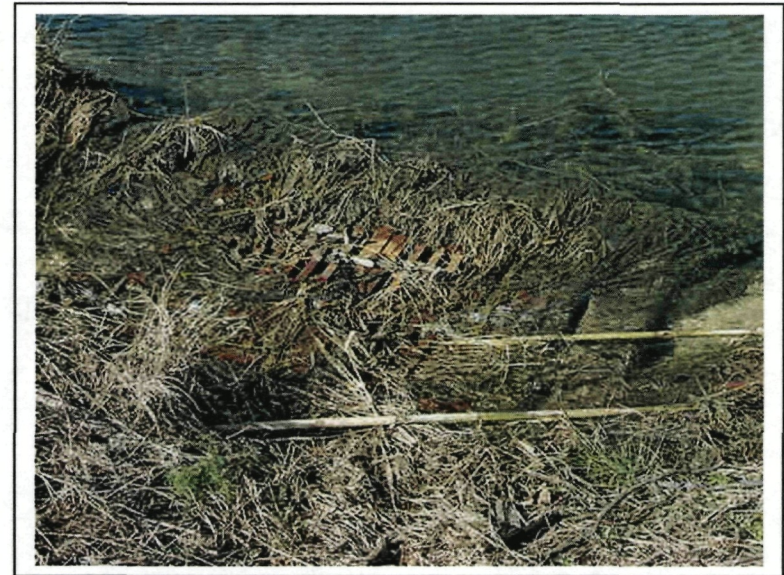
Photo 4. Drain pipe is clogging with debris.

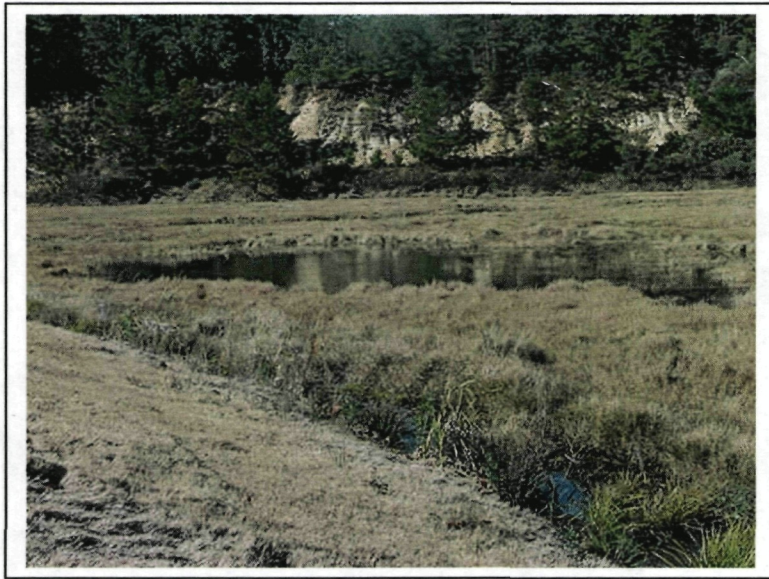
Photo 5. North end of pond, facing N, overgrown with *Panicum* spp.

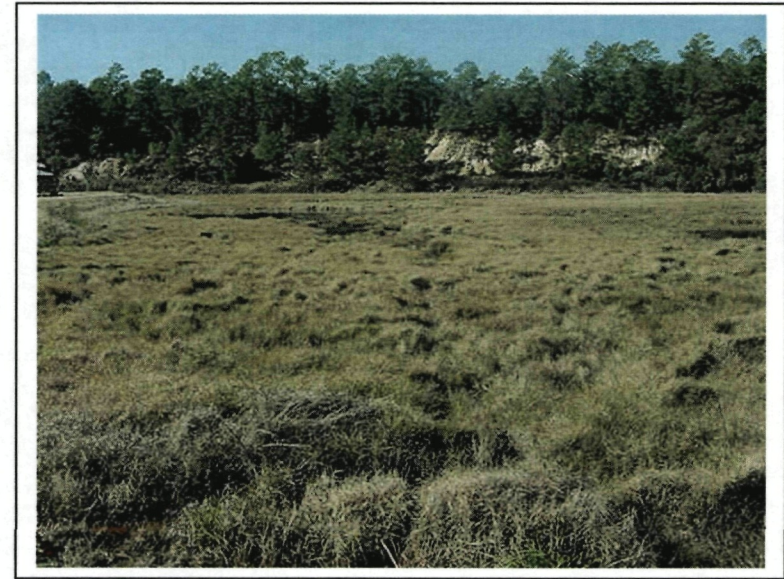
Photo 6. North end of pond, facing NE.

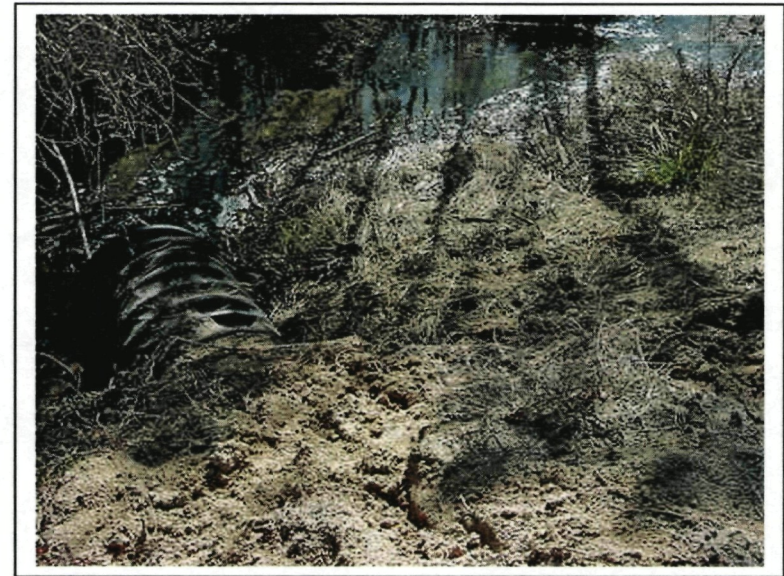
Photo 7. Banks of discharge pipe are not stabilized.
